Pearl Tangon Cultured Pearl Farm

Environmental Monitoring Report

**Myanmar Atlantic
Company Limited**

10 December 2020

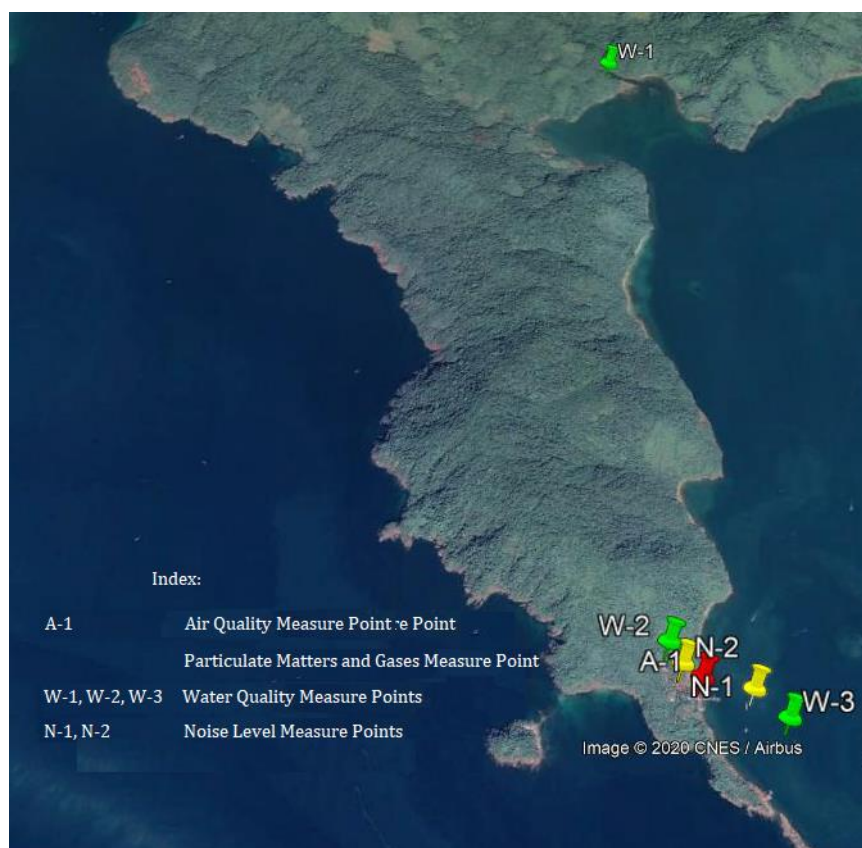
Figure (5) Environmental Measured Locations

Table (5). Environmental Measured Locations

Environmental Quality	GPS Value	Measured Devices	Location
Particulate Matters and Gases	A-1: Lat: 12° 16' 26.57" N, Long : 98° 00' 27.53" E	Drager X-am 2500 (MQG-0011) , and FLANK (F7707) <i>(onsite)</i>	Within proposed site
Noise (source)	N-1: Lat: 12° 16' 26.10" N, Long : 98° 00' 29.96"E (Port. A.-Main Jetty) & N-2: Lat: 12° 16' 27.43" N, Long: 98° 00' 25.6" E (Port. B. -Residential Area)	Digital Sound Level Meter (UNI-T-UT353) <i>(onsite)</i>	Within proposed site
Sea Water (site)	W-3; Lat: 12° 16' 35.11" N, Long : 98° 00' 42.20" E	<i>Sent to laboratory</i>	Within Long Line site
Water (community)	W-2: Tube Well Lat: 12° 16' 32.01" N, Long : 98° 00' 22.93" E W-1: Stream Water Lat: 12° 17' 35.34" N, Long : 98° 00' 1415" E	<i>Sent to laboratory</i>	Outside of proposed site, at water tank

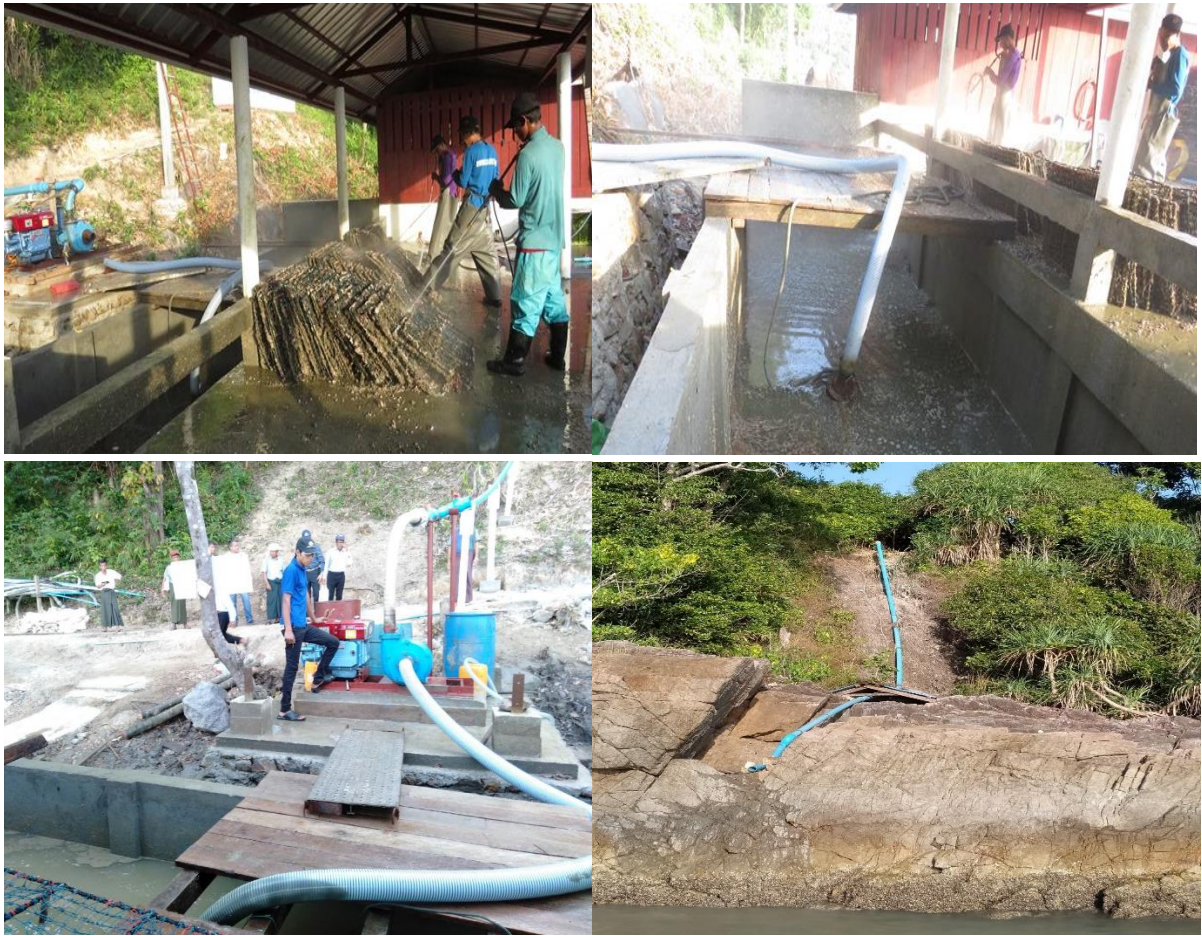
Figure (6) Panels cleaning site

There are management practices and operational methodologies that can be used to minimise effluent voided on lanes, tracks and hardstands and around gateways. The effluent management system was found as:

No.	Effluent Source	Effluent Volume	Effluent Liquid Waste Volume
1.	Panel Workshop - Pressure Pump unit - Panel Repairing unit	(2,000 panel/ day) 5,500gallon/day 300 gallon/day	(2,000 panel/ day) 300cuft (wet)110cuft (dry) 100cuft (wet)30cuft (dry)

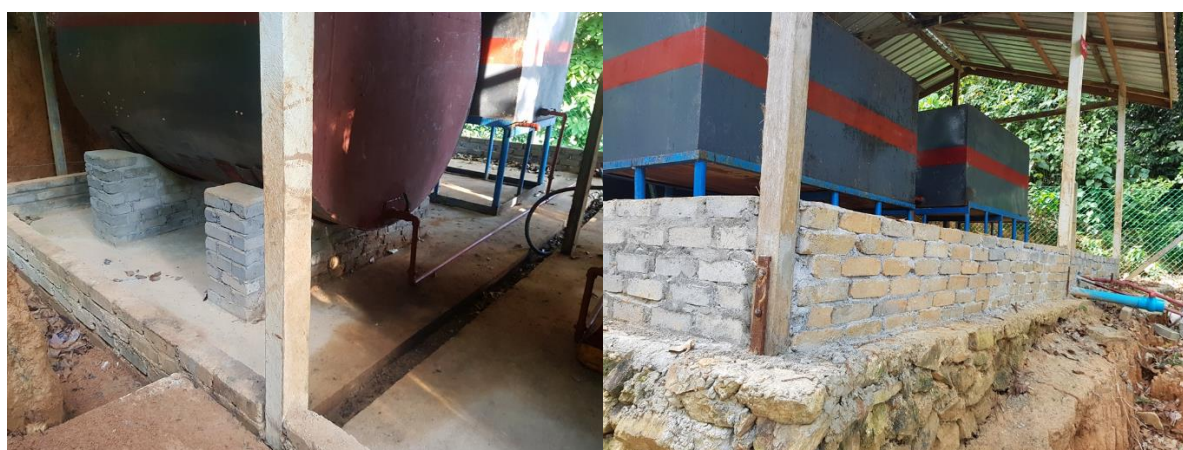
Figure (9) Containment walls for above ground fuel tanks

This concern mostly with the provision of containment walls for above ground fuel tanks and the provision of proper hazardous waste storage facility.

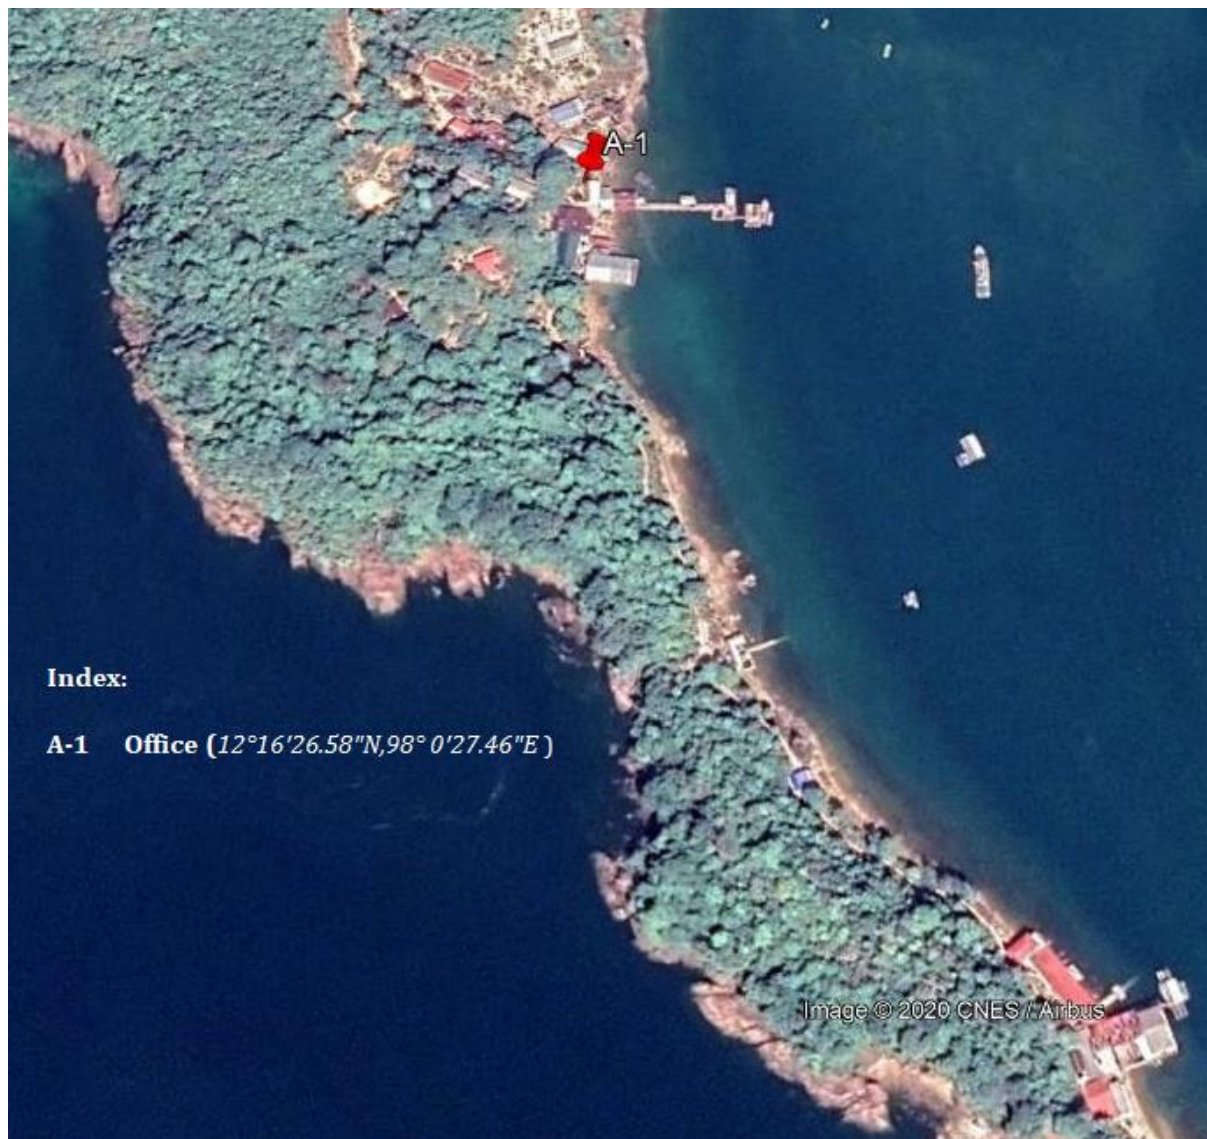
Figure (16) Location of Air Quality Monitoring Point

Air quality conditions in the PTF area are projected to be good due to its offshore location (40 mile south-west of the Myeik coast) and it is not identified as a specific issue. The ambient air quality measured at the perimeter of PTF area can provide some indication of the air quality within the project area. In this environmental monitoring for the PTF area, dust emission such as PM10 (particulates matter equal to or less than $40\mu\text{g}/\text{m}^3$) which can not affect human respiratory and PM2.5 (particulate matters equal to or less than $22\mu\text{g}/\text{m}^3$) which can not affect human lungs organs as the contents of gases and particulates emission to the ambient air were measured by on 11th and 12th February 2020 are shown in following table. The range of various pollutant levels measured at the perimeter of proposed project during the month of December are presented in below.

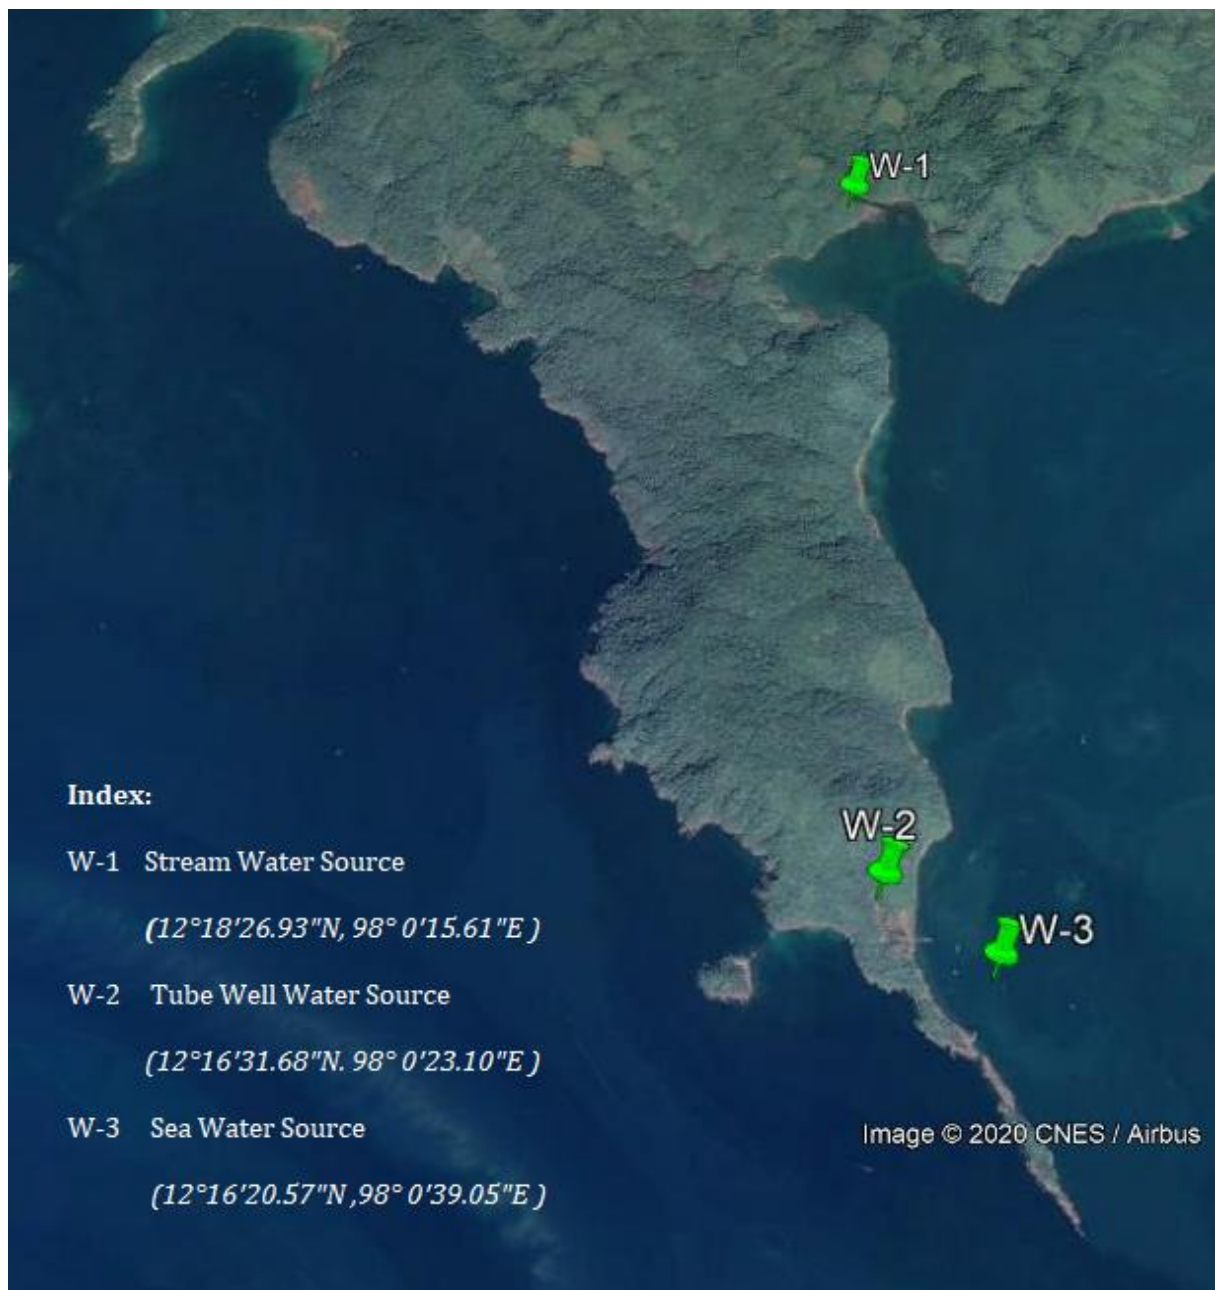
Figure (17) Location of Water Sources

The ground water quality analyzed from the tube well and Stream located in the project area can provide as good for drinking as some indication of the water quality. The following table shows the water parameters measured during the month of February 2020.

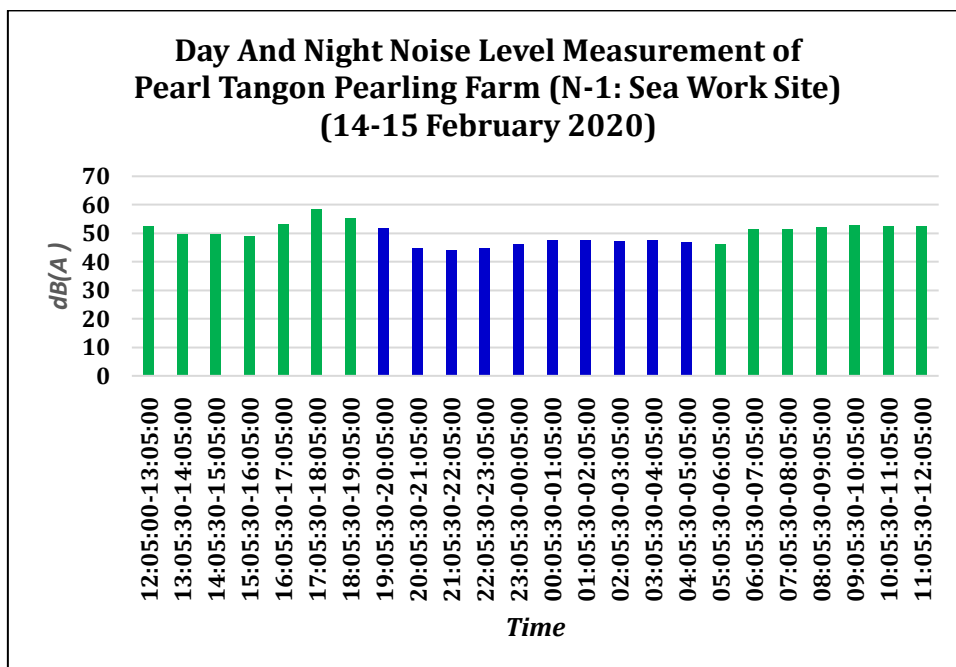
Receptor	NEQG	
	Daytime 10:00-22:00	Nighttime 22:00-10:00
Residential, institutional, educational	55	45
Industrial, Commercial	70	70

Figure (19) Noise Level Measurement of PTF (N-1: Sea Work Site)
