Pearl Tangon Cultured Pearl Farm

Environmental Monitoring Report

8 April 2020

**Myanmar Atlantic
Company Limited**

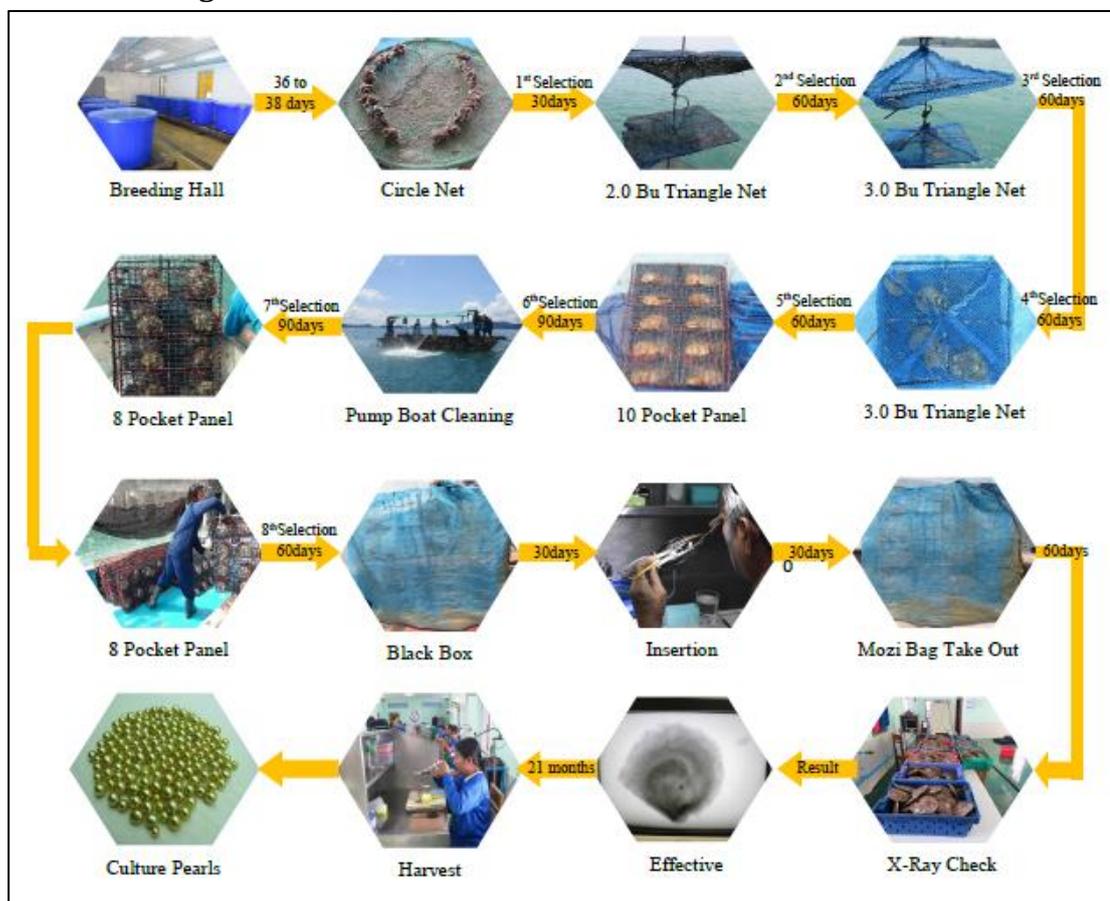
Figure (4) Operational Structure Design

Structure Design

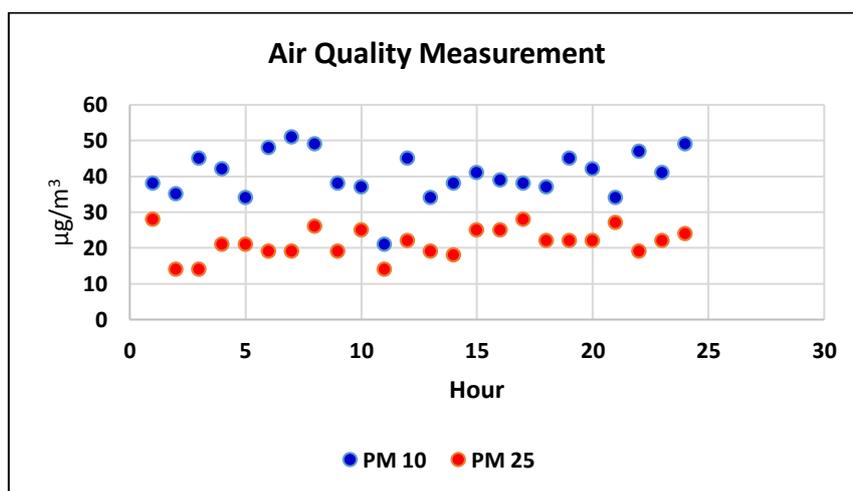
Figure (5) Air Quality Measurement

Air quality conditions in the PTF area are projected to be good due to its offshore location (40 mile south-west of the Myeik coast) and it is not identified as a specific issue. The ambient air quality measured at the perimeter of PTF area can provide some indication of the air quality within the project area. In this environmental monitoring for the PTF area, dust emission such as PM10 (particulates matter equal to or less than 40µg/m³) which can not affect human respiratory and PM2.5 (particulate matters equal to or less than 22µg/m³) which can not affect human lungs organs as the contents of gases and particulates emission to the ambient air were measured by on 12th and 13th December 2019 are shown in following table. The range of various pollutant levels measured at the perimeter of proposed project during the month of December are presented in below.

The ambient air conditions measured within the proposed project area provide some indication of the air quality within the project area. The measured values are as shown in Page 26-1 and 26-2. The mean concentrations of measured PM2.5 and PM10 values are within the range of WHO guideline values. Generally, the PM concentrations in the air are related to the microclimate conditions such as humidity, rainfall, temperatures of the proposed site. The temperature and humidity of the site on that day are 32°C and 62.40% respectively.

According to the measured concentration of the gases, all results indicated that they are well within the permissible limits of the international guidelines.

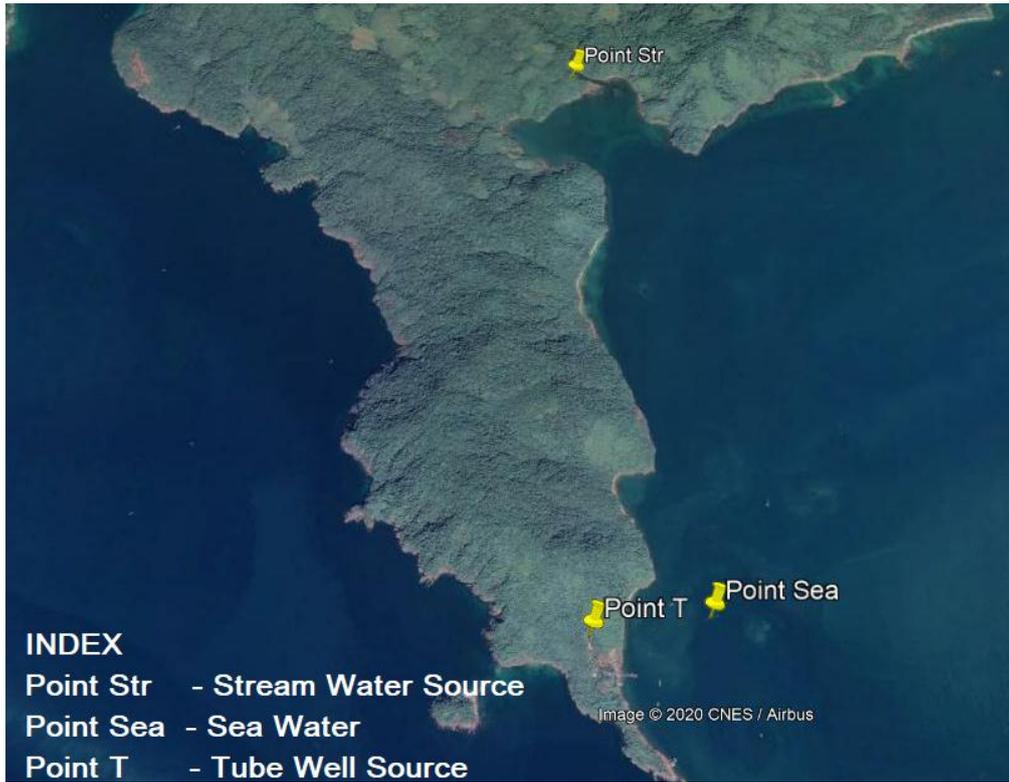
Figure (7) Location of Water Sources

The sea water quality analyzed from the sea site located in the proposed project area can provide some indication of the sea water quality of the project area. The following table shows the sea water parameters measured during the month of December 2019.

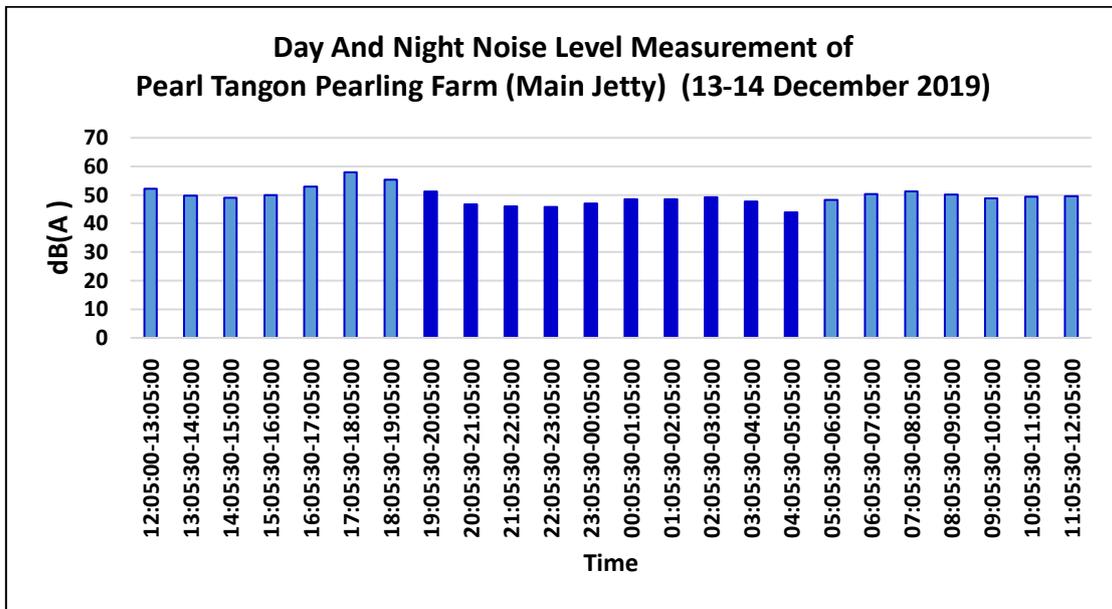
Figure (9) Noise Level Measurement of PTF (Main Jetty)

**National Environmental Quality (Emission) Guidelines
 is used to compare current with noise level**

Receptor	NEQG	
	Daytime 10:00-22:00	Nighttime 22:00-10:00
Residential, institutional, educational	55	45
Industrial, Commercial	70	70
